Fort Leonard Wood – Building 2101

Interior Character-Defining Features, Inventory and Assessment

April 2014

Final report

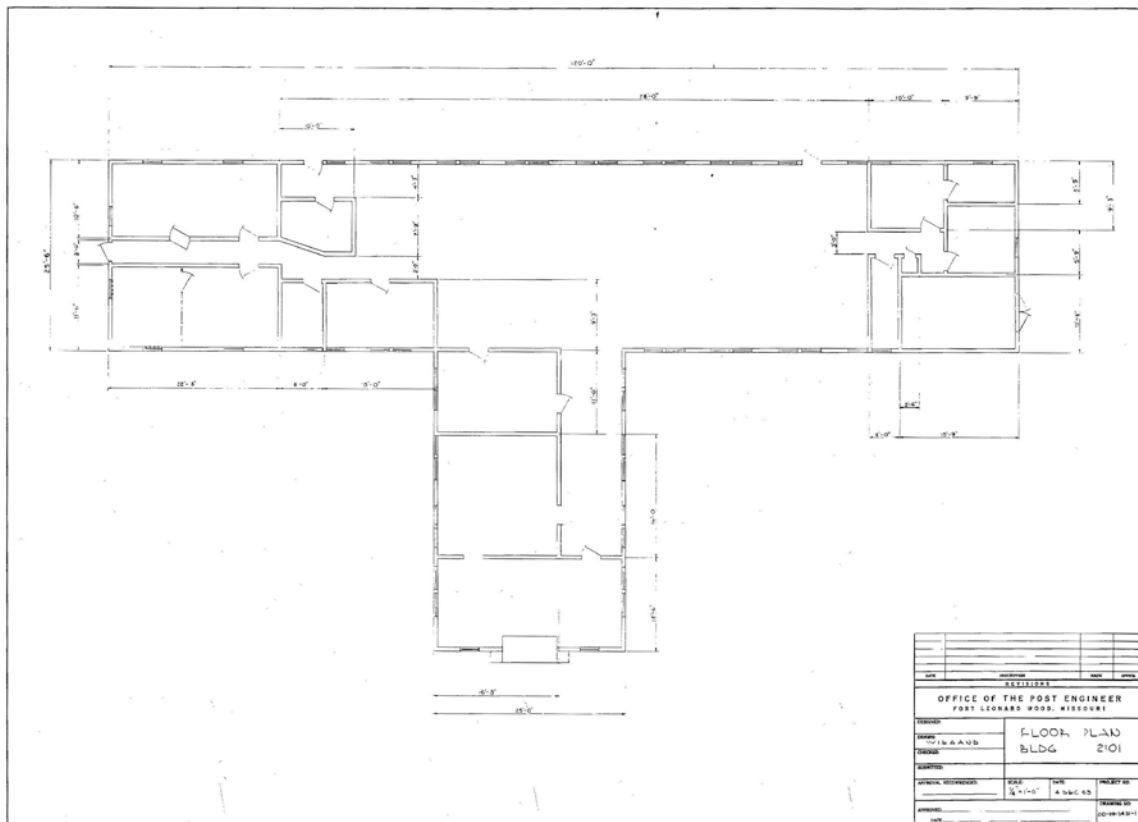
Figure 6. Building 2101 floor plan, 1965 (DPW at FLW).

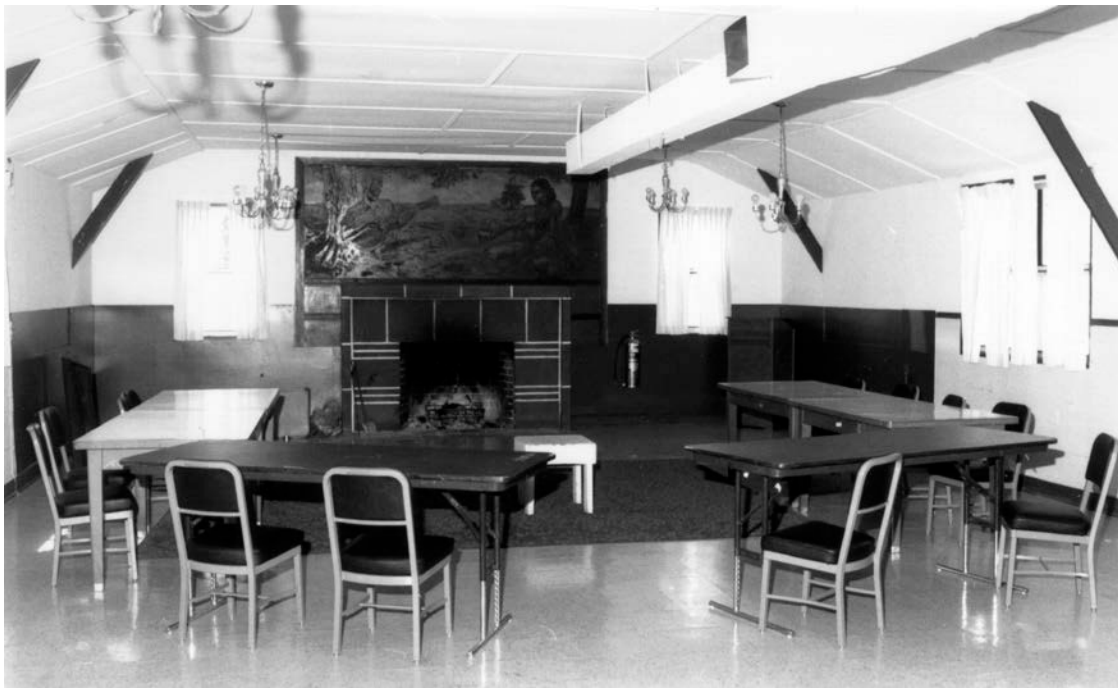
Figure 7. Interior of Building 2101 ell, showing the floor, wainscot, red painted fireplace, and light fixtures, no date (DPW, FLW).

Since no original light fixtures are extant and the only historic photo is of the ell (Figure 7), there can only be conjecture for what types of light fixtures were used when Building 2101 was an administration building and later, when the building was transformed into an officers' club. In addition, the chandeliers shown in Figure 7 are not found in any of the Army's Series 700 or 800 construction plans; however, since that photo does not have a date, it cannot be proven that the chandeliers date from the time Building 2101 was made an officers' club, although it is more than likely since the change in use and the addition of the ell occurred around the same time.

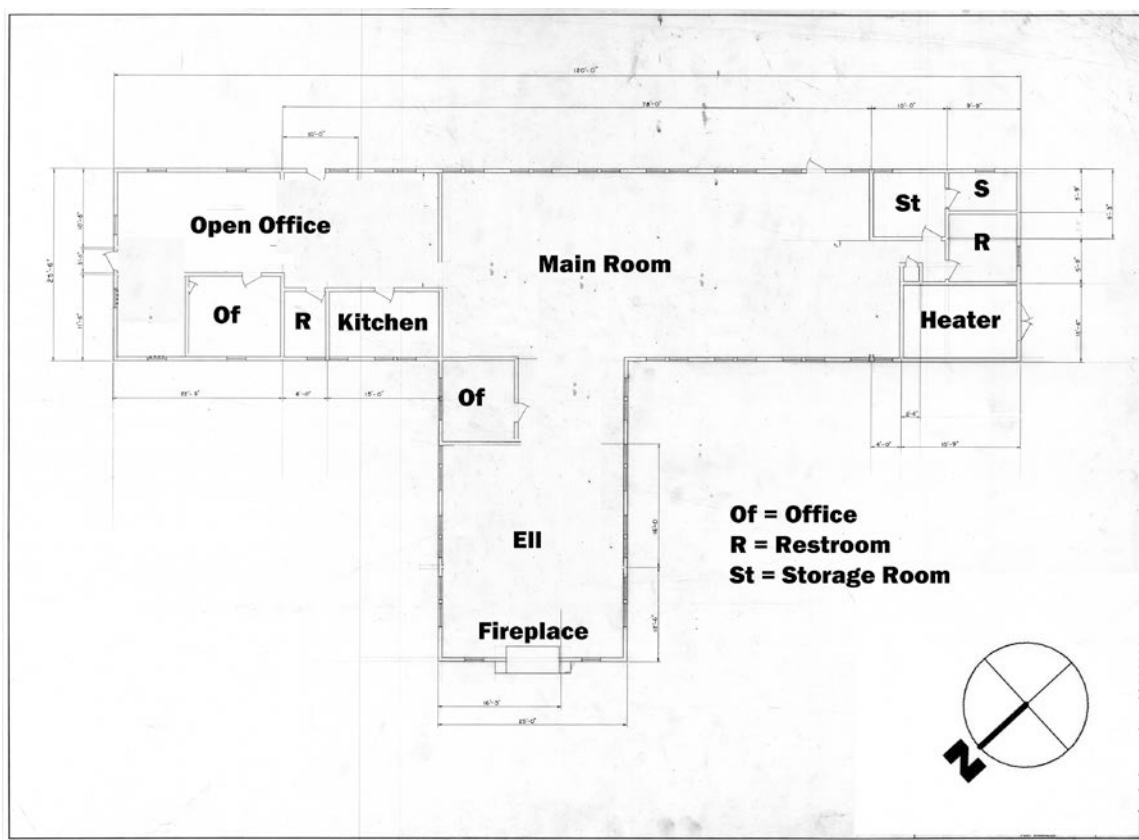
Since there is only one known historic photo of the interior of the Black Officers' Club and that photo is undated, and no drawings exist with DPW at FLW, the original floor plan layout after it was converted to a club is not known. The existing floor plan is shown in Figure 38, with room designations added. Due to the size of the ell and the placement in it of the German POW fireplace and the Samuel Countee mural, it has been assumed that the ell was a lounge/dance hall during the WWII period of significance. The heater room in the southwest corner of the building is original, but is not accessible by the public or from the inside of the building. The original wood wainscot in the southeast corner of the building (hallway, closet, and storage room) makes the case that those wall placements are original, and there were a series of small rooms at the southeastern end of the building. It is unknown if the full-height wall that separates the Main Room from the Open Office area dates from when the building was converted over to a club. It is also not known when the small rooms (kitchen, restroom, office) on the west side of the Open Office area were added to the building. The small office in the ell also is not original.

Figure 38. Existing floor plan (DPW, FLW – modified by ERDC-CERL).

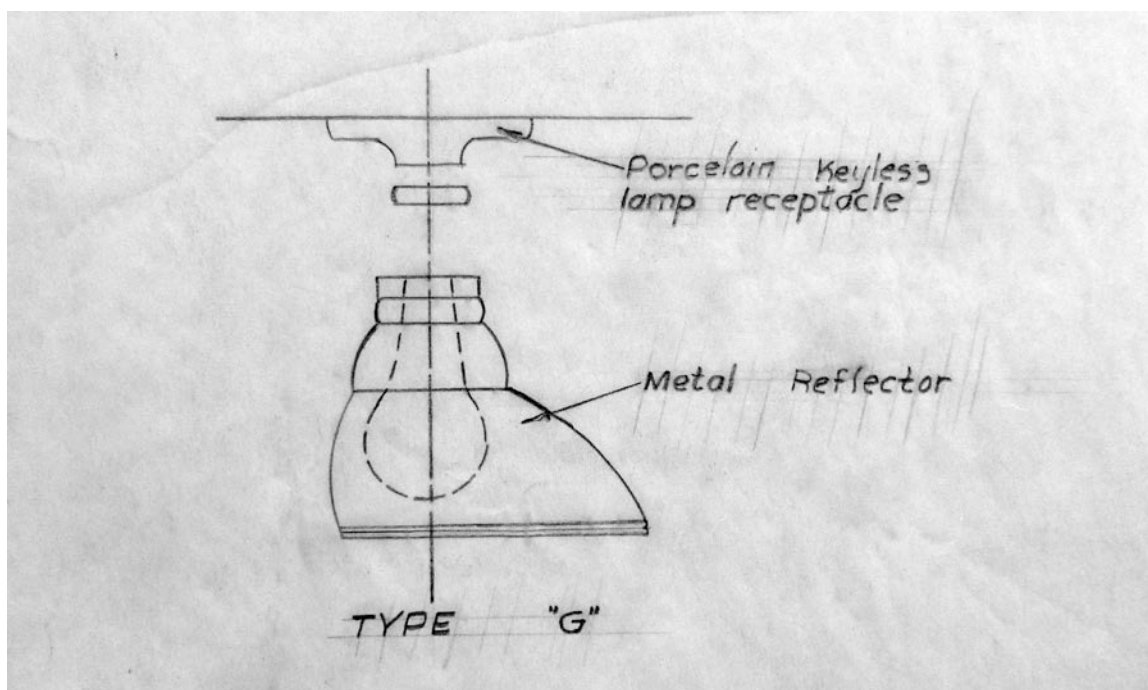
Light fixtures typical to the same type of building plan for WWII-era Series 700 buildings can be seen in Figure 39–Figure 41. These drawings informed the conclusion that none of the current light fixtures in the building are original (e.g., Figure 42). There are retro-style light fixtures in the ell of the building (e.g., Figure 43), but these are not replicas of the original light fixtures. In addition, there are electrical connection boxes on the ceiling that appear to mark the location of the original light fixtures (e.g., Figure 44).

Figure 42. Example of non-historic fluorescent light fixture (ERDC-CERL, 2013).
